Environmental Survey – Building 130 H  
Naval Station Great Lakes  
Great Lakes, Illinois

EDI Project No. 1602.032

August 23, 2011 Approved for Release By

**SUBJECT:** Environmental Survey - Building 130H  
Great Lakes, Illinois  
EDI Project No. 1602.032

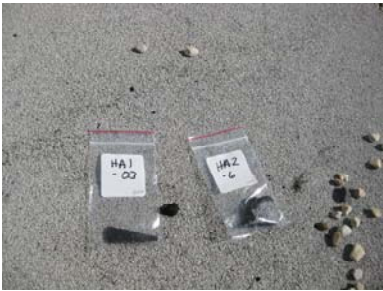
HA 1: Roof; roof field

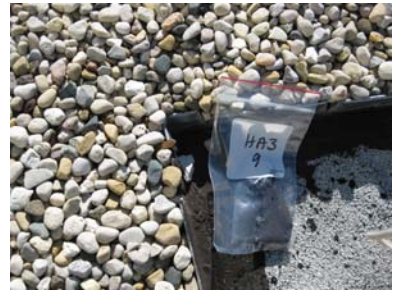
HA 3: Roof, roof caulk

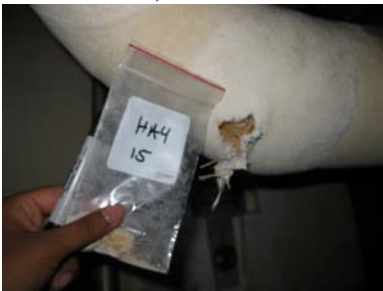
HA 4: Mechanical room  
206A, 3" joint insulation

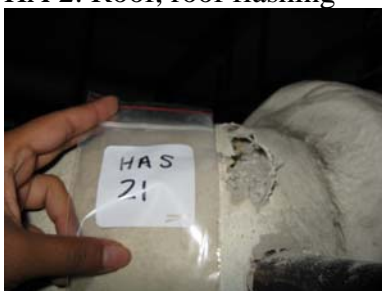
HA 5: Mechanical Room,  
8" joint insulation

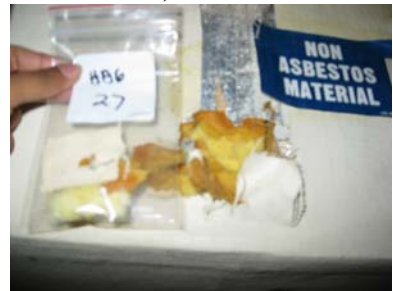
HA 6: Mechanical room,  
boiler breach

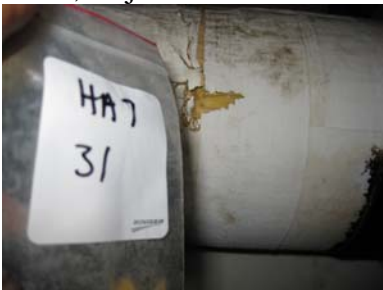
HA 7: Mechanical room  
206A, 10" elbow

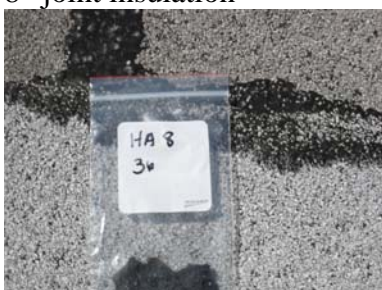
HA 8: Roof, roof field

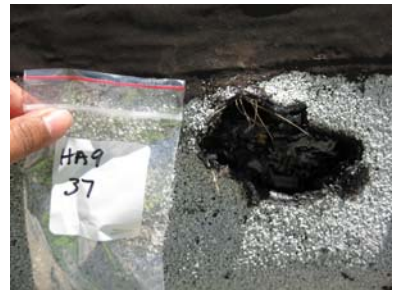
HA 9: Roof, roof flashing

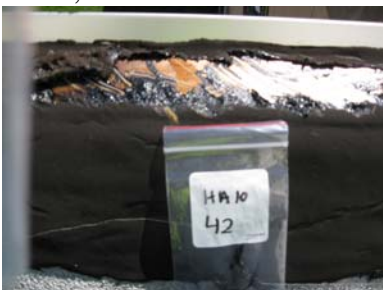
HA 10: Roof, roof caulk

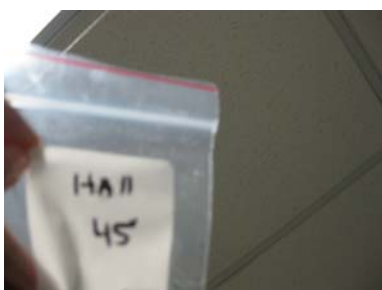
HA 11: Throughout  
building, 2x2 white ceiling  
tiles

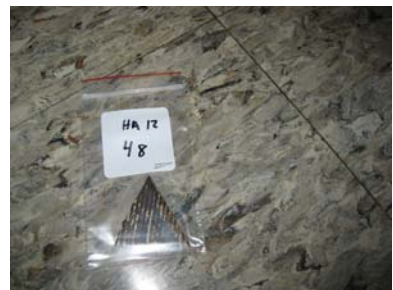
Location	Homogenous Area Description	Sampled Material Description	Sample ID	Results (% and type)	Test Method	Friability	Approx. Quantity Square feet (s.f) Linear feet (l.f.)	Condition
Throughout building- except stairwells, 2nd floor north hallway, and outside of "ring" hallway on 1 <sup>st</sup> and 2 <sup>nd</sup> floor	2 <sup>nd</sup> Floor hallway	1x1 Grey floor tile w/ specks and black mastic	HA12-46	PC 6.3 CH PC 3.1 CH	PLM	NF	25,000 S.F.	Good
Throughout building- except stairwells, 2nd floor north hallway, and outside of "ring" hallway on 1 <sup>st</sup> and 2 <sup>nd</sup> floor	2 <sup>nd</sup> Floor hallway	1x1 Grey floor tile w/ specks and black mastic	HA12-47	PC 5.8 CH PC 3.7 CH	PLM	NF		Good

HA 12: Throughout  
building, 1x1 grey floor  
tile with specks

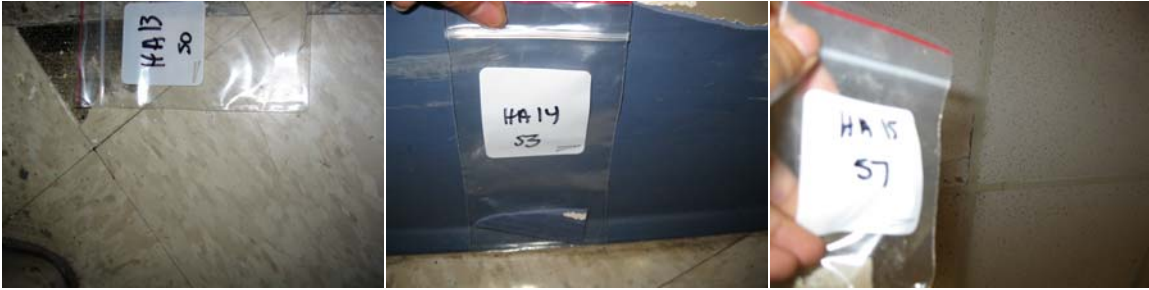
Location	Homogenous Area Description	Sampled Material Description	Sample ID	Results (% and type)	Test Method	Friability	Approx. Quantity Square feet (s.f) Linear feet (l.f.)	Condition
Throughout building- except stairwells, 2nd floor north hallway, and outside of “ring” hallway on 1 <sup>st</sup> and 2 <sup>nd</sup> floor	2 <sup>nd</sup> Floor hallway	1x1 Grey floor tile w/ specks and black mastic	HA12-48	PC 4.7 CH PC 3.3 CH	PLM	NF		Good
1 <sup>st</sup> and 2 <sup>nd</sup> floor hallway outside of the “ring” and in all stairwells	2 <sup>nd</sup> floor hallway	1x1 Beige floor tile w/ specks and black mastic	HA13-49	PC 3.2 CH	PLM	NF	12,000 S.F	Good

HA 13: Throughout building, 1x1 beige floor tile with blue specks  
 HA 14: Throughout building, blue mopboard  
 HA 15: Throughout building, 2x4 white lay-in ceiling tile fissured

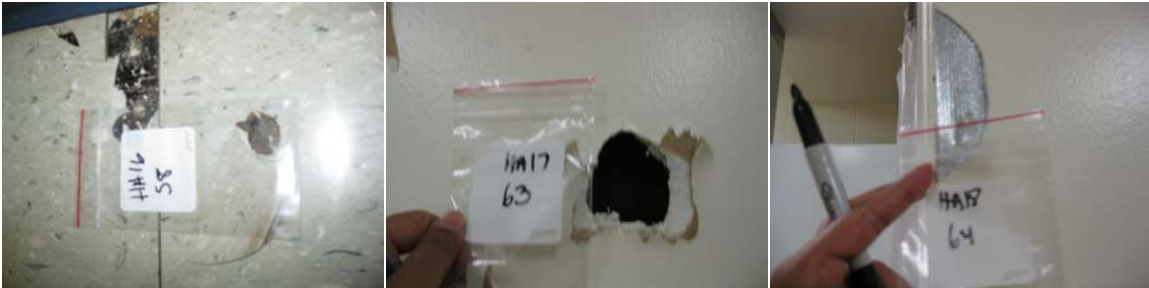
HA 16: Throughout building, 1x1 light grey floor tile with blue specks  
 HA 17: Throughout building, drywall  
 HA 18: Throughout building, drywall joint compound

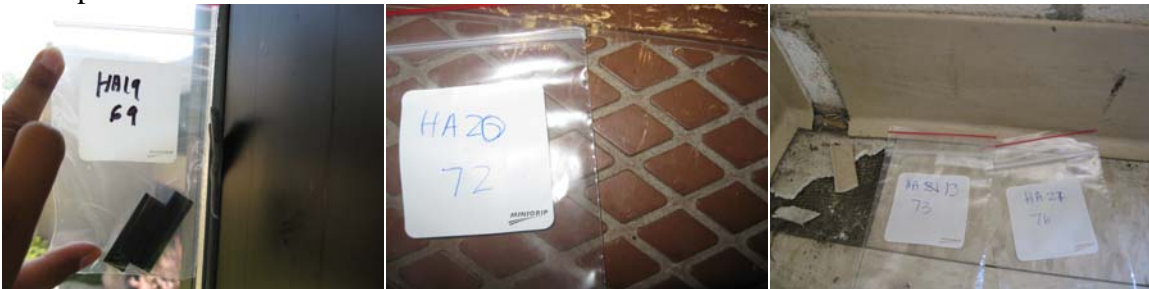
HA 19: Throughout building, window caulk  
 HA 20: Stairwells, brown stair tread  
 HA 21: 1<sup>st</sup> floor stairwell, beige mopboard

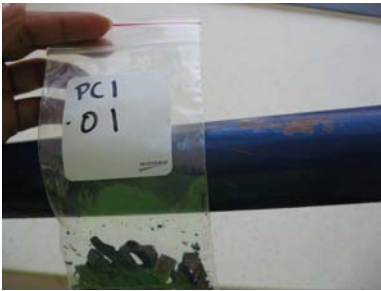
PC 1: Throughout building,  
blue paint

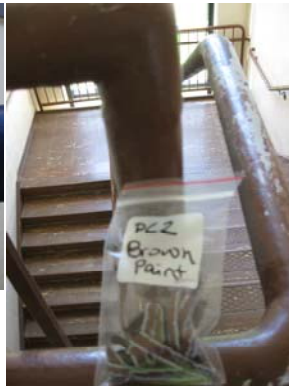
PC 2: All stairwells, brown  
paint

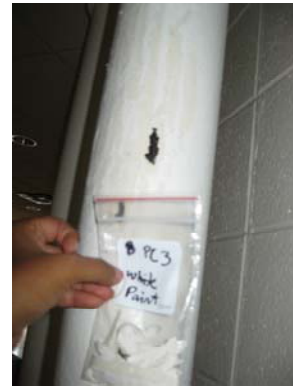
PC 3: Throughout building,  
white paint

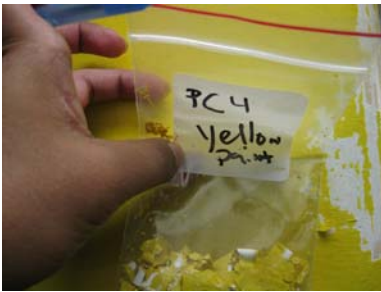
PC 4: 2<sup>nd</sup> Floor male  
bathroom, yellow paint

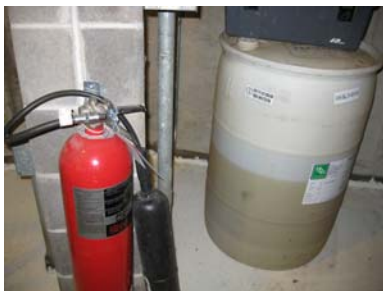
The 2<sup>nd</sup> floor mechanical room, contained drums of various chemicals that may be hazardous. There were two 55- gallon drums of cleaner and cool water treatment. There were also 5 gallon barrels of cleaners and Spectrus OX103. In mechanical rooms 147 and 247, air conditioning equipment was observed, that may contain freon. Pipe wraps in mechanical rooms 147 & 247 appeared to be fiberglass. The Hazardous Materials Table is provided in Appendix C. Photographs of hazardous materials identified are shown in Appendix D. Suspect hazardous materials should be removed, handled, and disposed of in accordance with applicable federal, state, and local regulations. The following hazards were not observed inside Building 130H: USTs, ASTs, or gas cylinders. However, the inspector did not have access to many rooms in the building. EDI recommends that tenant-stored materials requiring special handling and disposal, such as the air conditioning units, polychlorinated byphenols (PCBs) fluorescent light ballasts, exit signs, potential mercury-containing devices, fire extinguishers, refrigerators and vending machines, and hazardous chemicals be removed prior to renovation of the building.

Photo 1: Room 206A, view of chemicals and fire extinguisher

Suspect hazardous materials should be removed, handled, and disposed of in accordance with applicable federal, state, and local regulations. EDI recommends that tenant-stored materials requiring special handling and disposal, such as the air conditioning units, polychlorinated biphenols (PCBs) fluorescent light ballasts, exit signs, potential mercury-containing devices, fire extinguishers, chemicals, refrigerators and vending machines, and hazardous chemicals be removed prior to renovation of the building.

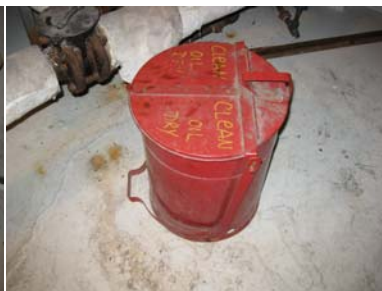
Photo 2: Room 206A, view of oily rag drum

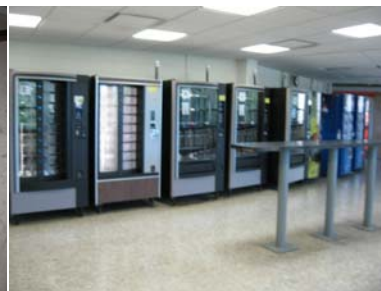
Photo 3: 2<sup>nd</sup> Floor (ring) hallway, view of vending machines

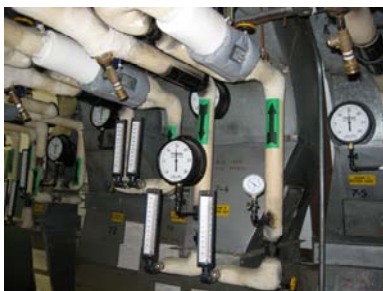
Photo 4: Room 206A, view of thermostats

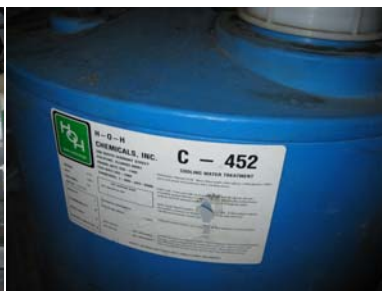
Photo 5: Room 206A, view of hazardous chemical drum

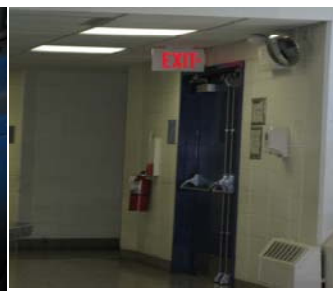
Photo 6: 2<sup>nd</sup> floor hallway, view of exit sign and fire extinguisher

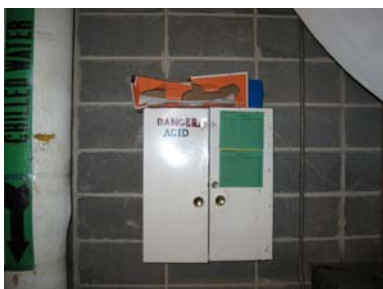
Photo 7: Room 206A, view of acid cabinet

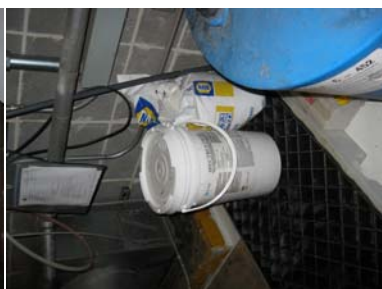
Photo 8: Room 206A, view of chemicals

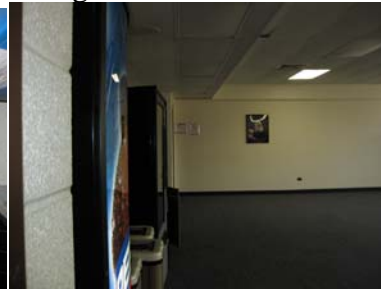
Photo 9: Room 229, view of vending machines

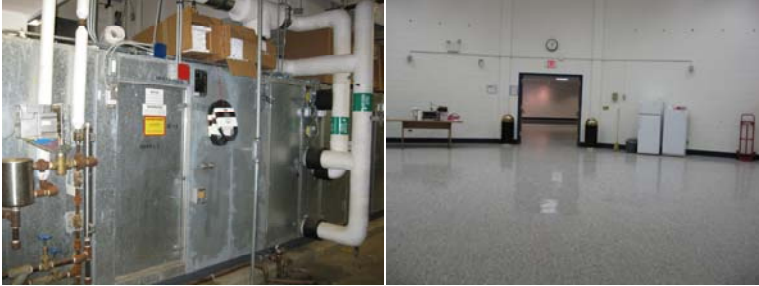
Photo 10: 1<sup>st</sup> Floor  
mechanical room, view of  
air conditioning units

Photo 11: Auditorium, view  
of refrigerators and an exit  
sign
